## HIGH SPEED FERRY PROPELLER CAVITATION DAMAGE REPAIR

Tuzla, ISTANBUL, TURKEY

April 2019

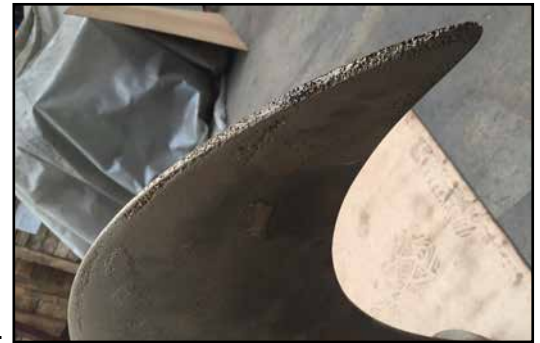
Cavitation damage on both propellers of high speed ferry. The damage is more intense on the blade leading edges. The damaged propellers causing ferry two operate with some vibration and less hydrodynamic efficiency.

1. Cavitation damage on the propeller
2. After surface preparation
3. Application Belzona 1311
4. The surface faired after Belzona application
