BELZONA REPAIR STRAINERS

Fishing vessel strainers

Strainers badly eroded

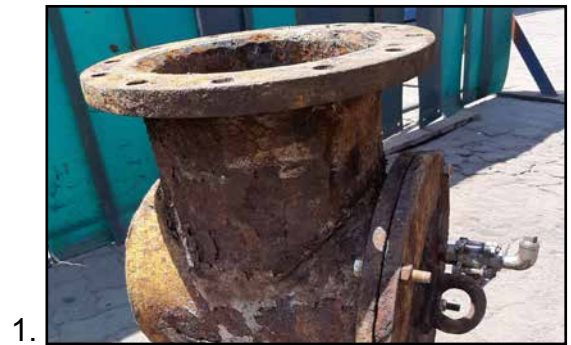
1. Strainer badly corroded
2. Strainer Flange
3. After grid blast
4. Final product done with Belzona 1111 and Belzona 1321, with Belzona 5811 on the outside.
