BELZONA PROVIDES EXTERNAL CORROSION PROTECTION FOR LNG TERMINAL PIPELINES

Taiwan LNG Terminal

December 2013

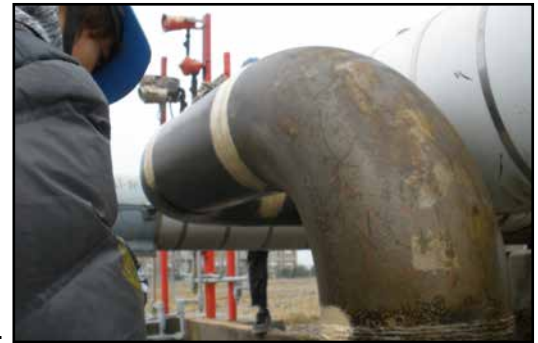
Condensation has caused premature failure of the original coating on LNG pipelines. Meanwhile, condensation is continuously generating in the pipeline so that traditional corrosion protection coating unable to apply.

1. Corroded pipelines
2. Surface preparation with high-pressure water
3. Apply Belzona 5831 on-site
4. Application complete
