BELZONA REPAIR TO CORRODED PROPELLER SHAFTS

Durban South Africa

February 2020

Two propeller shafts on heavy utility vessel, 6.5 m long and 100 mm in diameter. Constantly submersed in sea water.

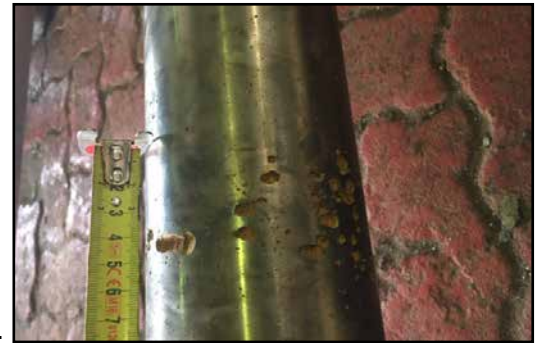
Two propeller shafts on a port utility vessel were badly corroded from bimetallic corrosion and eroded due to wear from gland packing. If left untreated, significant structural damage would occur and replacement would be imminent. The cost of replacement is prohibitive, as well as down time required.

1. Damaged shafts showing corrosion damage
2. Grit blasted and machined shaft
3. Undercut rebuilt with Belzona 1111, ready for final machining
4. Completed shafts, ready for fitment

Application carried out in accordance with Belzona Know-How System Leaflet MPT-01. Once rebuilt and machined to original spec, a two coat system of Belzona 1341 was applied to protect the exposed shaft area from future corrosion.
