BELZONA COMPOSITE REPAIR ON-SITE APPLICATION FOR BURIED NATURAL GAS PIPELINES

Sichuan, China

August, 2013

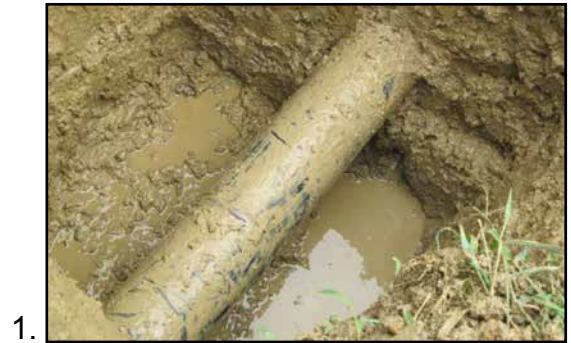
1. Buried pipeline
2. Damaged external surface
3. Dry wrapping of the reinforcing sheet;
4. Application complete

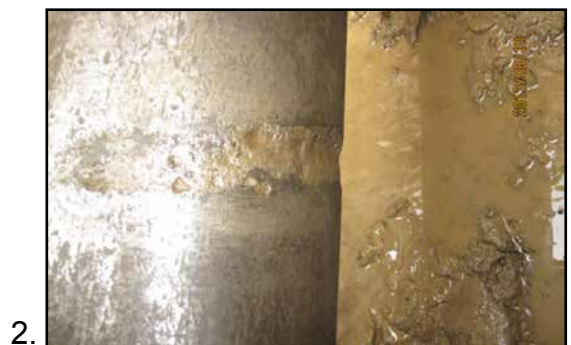
The operating pressure of these buried gas pipelines is 2Mpa; Maximum depth of external metal loss is 6.7mm; The corrosion area is 40x60mm. These pipelines have been immersed in a humid environment for a long time, and the surface of the pipeline cannot be dried.
