BELZONA REPAIRS A BALCONY

Repair of a 2nd floor apartment balcony in the center of Zagreb.

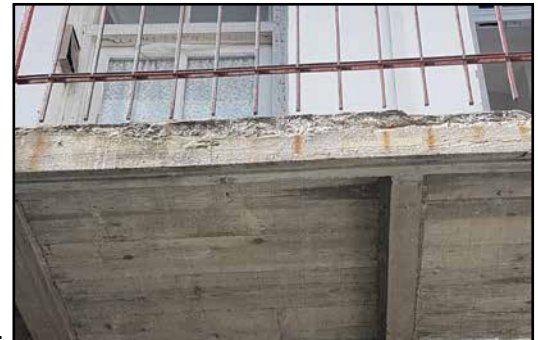
The balconies were repaired 30 years ago. Due to age, carbonation of concrete, exposure to rain/snow and water ingressing into cracks, at the edge of balconies the pieces started to fall down. This was a safety hazard for people walking beneath.

1. Damaged balcony
2. Surface preparation, drying after washing
3. Application completed
4. Application completed (side view)
