## BELZONA PROTECTS ICE BREAKER RESEARCH SHIP

An ice-breaking polar supply and research ship returned to dry dock in South Africa for repairs after polar exploration.

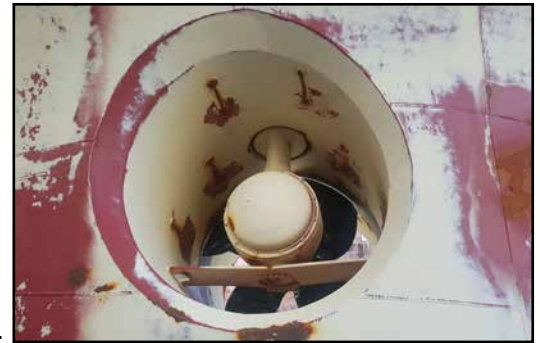
Areas and fixtures on the hull have been subjected to wear and erosion in service, leaving some of the steel exposed and open to corrosion.

1. Repair area prior to application
2. Detailed damaged area with steel loss
3. Coating application complete
4. Additional protection added to most severely affected areas
