BELZONA REPAIRS DESULFURIZATION AND DENITRIFICATION PUMP CASING AND PROVIDES LONG-TERM PROTECTION

Xianyang, Shaanxi, China

December 2019

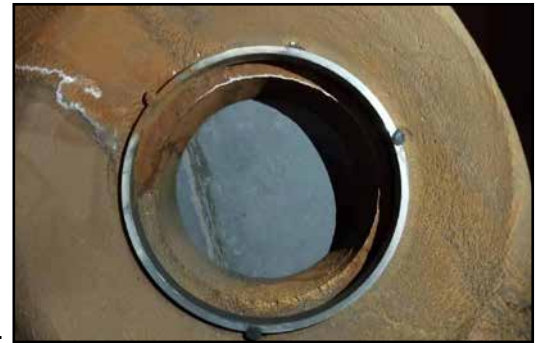
Leaking pump casing and seriously corroded runner.

1. Damaged pump casing
2. Grit-blasting internal part of the casing
3. Repair the leakage of the pump casing
4. Application complete
