BELZONA ELASTOMER REPAIRS A FRANCIS TURBINE

Damaged Francis Turbine

Mechanical damage of Francis turbine blades due to strong cavitation.

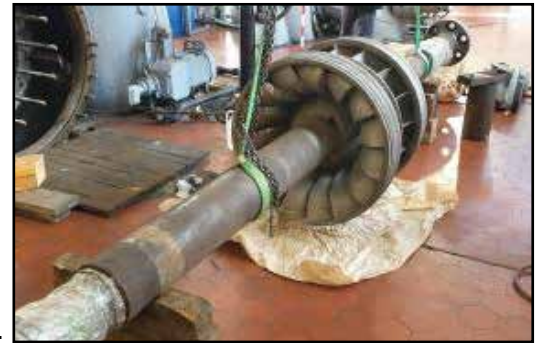
1. Francis turbine rotor after grit blasting
2. Re-profiled with Belzona 1221
3. Application of Belzona 2141
4. Completed Application

Abrasive grit blasting. Dedusting and degreasing the surface with Belzona 9121. Re-profiling cavities with Belzona paste 1221 Application Belzona 2941 and then Belzona elastomer application 2141 in a system of two layers. In line with Belzona Know-How System Leaflet CEP-3.
