BELZONA REPAIRS DIESEL ENGINE

100 cylinders required repairing or would be replaced.

Pitting corrosion on engine block o-ring seats had caused failure.

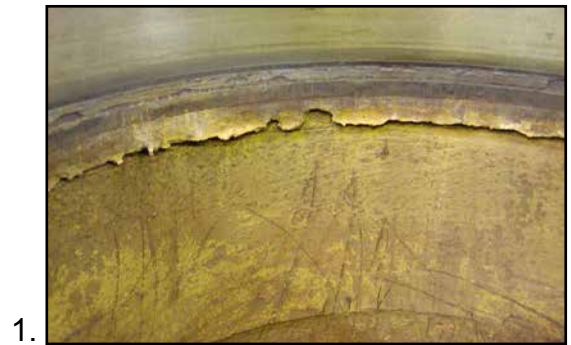
1. Damaged area
2. Surface preparation
3. Belzona 1111 rebuild
4. Belzona 1111 machined
