CAVITATION PROTECTION FOR WATER PUMPS WITH BELZONA

Water treatment plant, Egypt

End suction centrifugal Water pumps

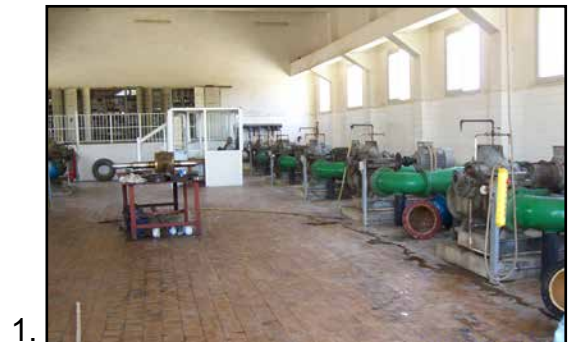
1. General view of the pumps
2. Erosion/Corrosion damage
3. The cavitation area after blasting
4. Completed application

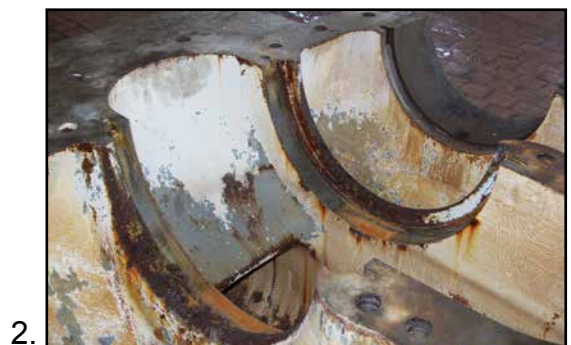
General erosion/corrosion damage and severe cavitation leads to reduced pump efficiency.
