BELZONA REPAIR EROSION/CORROSION DAMAGE TO ABSORBER

Chemical Plant - Northwest UK

Carbon Steel Bubbler Hood

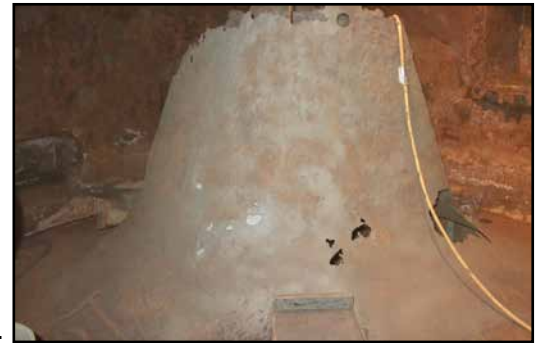
Extensive damage to equipment caused by erosion corrosion issues.

1. Bubbler Hood post blasting
2. Bonding of plates using Belzona 1121
3. Bonding of new dome piece
4. Overcoating of application using Belzona 1391

This application was carried out with a modified version of Belzona Know-How System Leaflet TCC-5. After surface preparation was completed by grit blasting Belzona 1121 was used utilising its extended working life to bond the large contoured plates to damaged area then Belzona 1391 was applied to give maximum protection to process conditions.
