BELZONA FLANGE ENCAPSULATION SYSTEM PROTECTS FIRE SYSTEM

Cogeneration plant, Taiwan

Fire extinguishing system

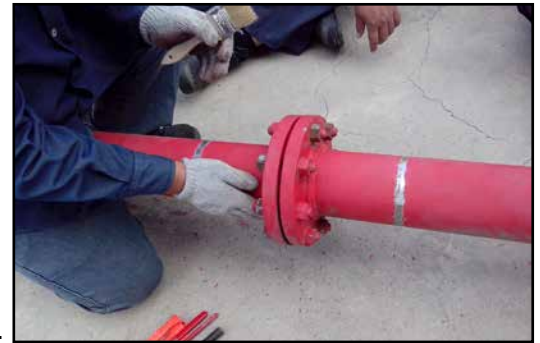
The flange and bolts were suffering from corrosion problems due to the coast nearby.

1. Overview of fire extinguishing system
2. Surface Preparation and applying Belzona 8411 as a corrosion inhibitor.
3. Applying Belzona 3411
4. Application completed
