PROPELLER BLADES CAVITATION PROTECTION

APPLICATION SITUATION
New propeller blades cavitation protection

PROBLEM
Cavitation on older propeller blades in service demanded protection of new propeller blades.

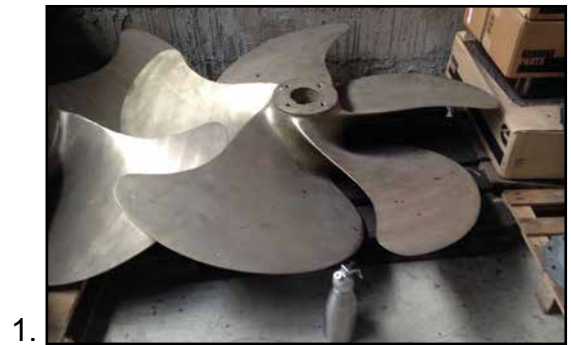
- PICTURES**
1. Propeller
 2. Blade
 3. Surface preparation
 4. Belzona 1321 applied
