## BELZONA ELASTOMER USED TO REPAIR TORN CONVEYOR BELTS AT RECYCLING PLANT

Recycling Plant - Zurich, Switzerland

April 2019

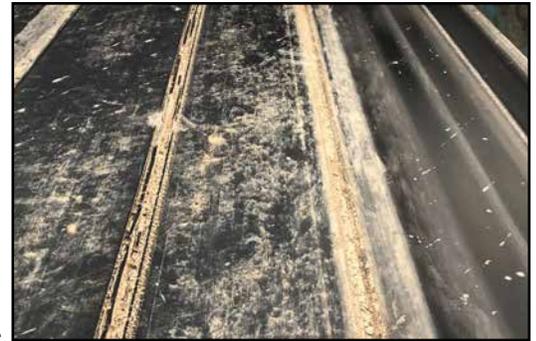
A recycling plant specialising in urban mining, extracting and reusing building materials from previous sites e.g. concrete. At the facility, a large conveyor belt had become caught on a defective scraper, causing a linear tear over 32m along the rubber.

1. Damage along the length of the conveyor belt
2. Heavy scoring and tears resulted in shutdown
3. The repair area masked off for application of Belzona 2311
4. The Belzona repair allowed for a return to service the next day
