## BELZONA PROVIDES A HARD WEARING GRIP SYSTEM FOR WHISKY BOTTLING PLANT

Glasgow

May 2017

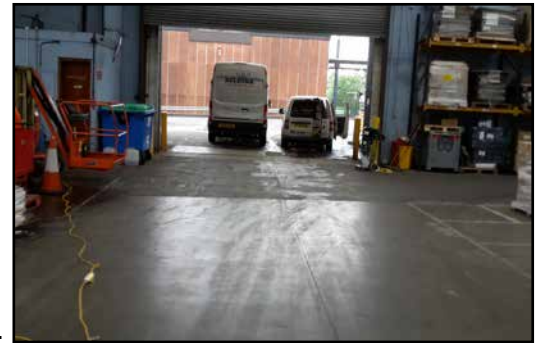
A pallet dispatch yard in a Whisky bottling plant had a health & safety issue caused by poor traction on the concrete floor. During rain showers water would be brought inside the building on forklift truck wheels. This rainwater was causing a slip hazard for both the forklifts & workers in the area. The heavily trafficked area in need of a grip system was over 200 m<sup>2</sup>.

1. Area in need of grip system
2. Surface preparation
3. Product during application
4. Completed section
