BELZONA COATS A HYDRO POWER PUMP SHAFT

In the course of a general refurbishment and performance increase of the pump, a new impeller was installed which changed the profile. This required a change in the contour of the shaft, which is where Belzona was required. The areas of the shaft in contact with water were coated with Belzona 5811.

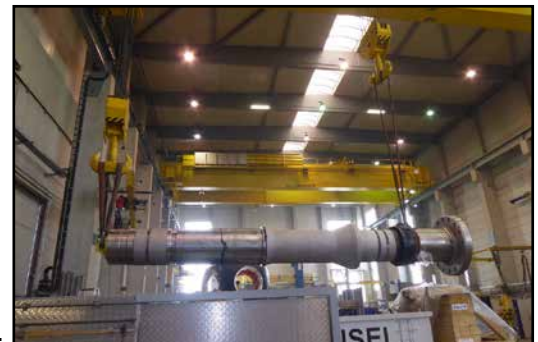
1. Hydro Power Pump Shaft Positioned into place.
2. The contour was roughly built up in several layers with Belzona 1121.
3. The new contour after coating with the first of two layers of Belzona 1321.
4. Completed Application
