BELZONA RESURFACES DETERIORATED BIKE RACK AT UK COLLEGE FACILITY

CUSTOMER
Yorkshire, UK

APPLICATION DATE
April 2019

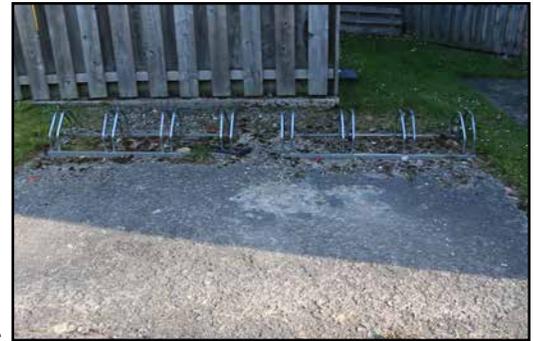
APPLICATION SITUATION
The bike rack at a UK college facility was showing significant signs of deterioration, with vast areas of the concrete surface spalled or cracked due to wear and weathering.

- PICTURES**
1. Bike rack showing large areas of spalled and deteriorated concrete
 2. Application of Belzona 4131
 3. Resurfacing the final area of the bike rack
 4. Revisited several weeks later and in perfect condition
