BELZONA RESTORES A TANK ROOF IN HUNGARY

The Oil refinery were looking to reduce liquid temperatures in the tanks, the current tanks roofs were very dark and grey and were not reflecting the light sufficiently.

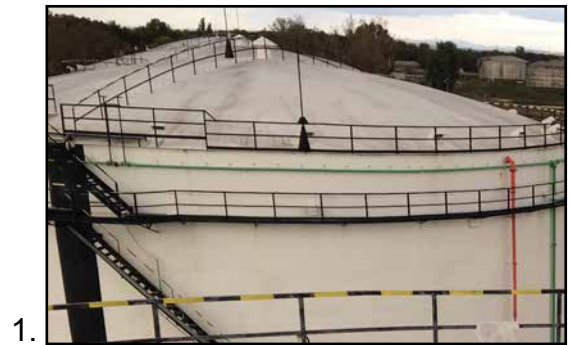
The tanks roofs were heavily polluted with a dirty grayed appearance generating higher temperature and so more evaporation of high volatile fuel in the summer period. This is a huge loss of product for the asset owner.

1. Polluted tank roof (before)
2. Belzona 6111 Liquid Anode used as a primer on the blasted surface.
3. Belzona 5111 Ceramic Cladding White was sprayed.
4. Condition check after 4 years. No problem, perfect performance.
