VOLUTE PUMP INTERNAL LINING REPAIRED WITH CHEMICAL RESISTANT PROTECTIVE COATING

Power Plant Ras Laffan Qatar

Dec-20

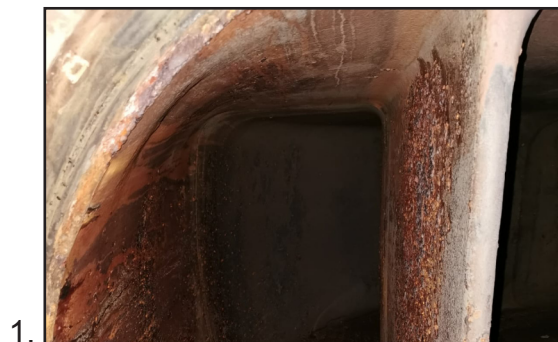
Internal lining was severely damaged, general corrosion all over the surface is evident and deep pitting on inlet sitting area and on outlet flange face

1. Appearance of the pump before blasting
2. Pump after blasting
3. During coating application
4. Application complete with Belzona 4311

Surface preparation by grit blasting is carried out to remove rusts and corrosion residues as well as to expose unforeseen pitting to evaluate the amount of caulking material to be used. Rebuilding application on all exposed pitting takes place after blasting is completed and cured for 2 hours. After curing, sweep blasting has been conducted all over the surface which includes the surface of the rebuilding material, followed by application of Belzona 4311 chemical resistant coating in two coat system.
