HYDRO POWER KAPLAN TURBINE CASE COATED WITH BELZONA

The impeller shell of the Kaplan turbine at a Hydro power plant was badly damaged by cavitation and wear over several decades.

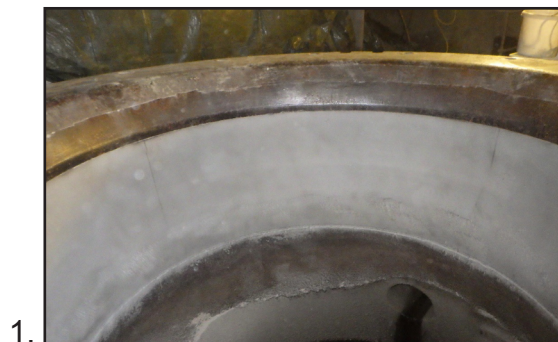
1. The turbine casing after sandblasting.
2. Before the reconstruction, a template of the target shape was made.
3. Belzona 1311 applied to rebuild the profile.
4. Complete with a top layer of Belzona 1321

Blasted to 90µm roughness according to Testex with abrasive Asilikos 0.2-1.4 (carried out by Bauschutz) Residual moisture burned out of the casting Flaws slightly raised and rebuilt with Belzona 1311 - curing: 18 hours at 15 °C Reconstructed areas ground to the target contour Swept jacket - Belzona 1311 spots were slightly roughened and bare steel surfaces were derusted Coating of the jacket with two layers of Belzona 1321 - the first layer was completely covered within 2 hours - total target layer thickness: 600 µm Applications carried out in line with Belzona system leaflet CEP-5
