BELZONA SEALS AIR COOLER COVER

Ship Repair Workshop, Turkey

Air Cooler Cover Connection Line

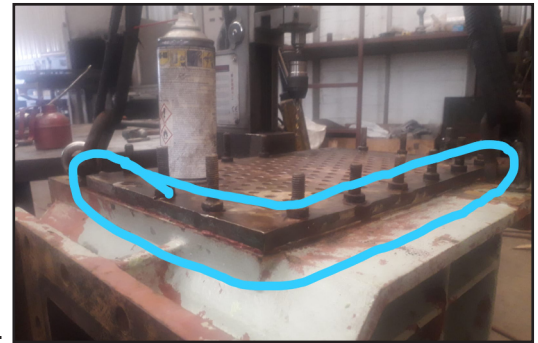
Due to the design of the Air Cooler, the gasket under the cover could not be changed. Over time and vibrations of Cooler, the deformed gasket lost its sealing and caused the performance of Air Cooler to decrease.

1. Leaking Area
2. Defining the application Area
3. Filling between cover and case with Belzona 2211.
4. After the application finished.
