BELZONA GUIDES ITS CLIENTS INTO REBUILDING & PROTECTING AN ASSEMBLY LINE BUFFER CHAIN GUIDE

Levelling off wear at the bottom of a buffer chain guide on an automotive assembly line.

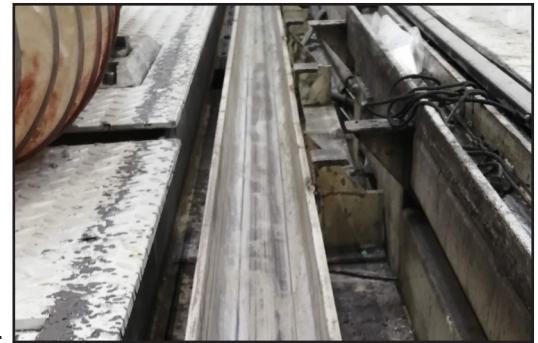
The conveyor chain had worn the channel that guides it by 6-8mm over a period of 10 years.

1. Problem Area
2. Specific Grit-blasting Dust Extraction Tool
3. Application of Belzona 1311
4. Final Application

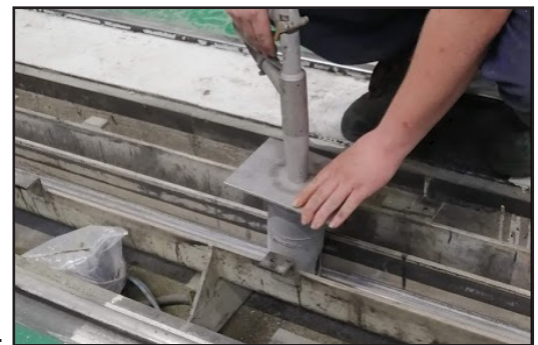
2.

The client couldn't afford to have any dust in the vehicle assembly block, this forced the Distributor to form their own grit blasting dust extraction tool allowing them to not only blast but also contain and recuperate the grit, minimising the spread of dust. The client was astonished by not only the Distributors ability to work within tight constraints but also by the possibility of using Epoxies to repair rather than replace the whole chain guide.

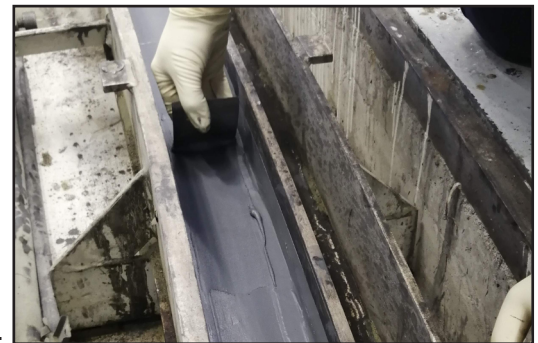
3.

After chute degreasing and stripping, reloading of worn areas with Belzona 1311 and application of Belzona 1321 coating (both containing Ceramic fillers) in order to reduce future wear rate. The application was carried out in accordance with Belzona System Leaflet GSS-5 & GSS-9.
