## MARINE SEWAGE TANK REPAIRED WITH BELZONA

A marine sewage tank was identified as having thin wall areas on its base caused by corrosion. The existing protective coating system inside the tank had broken down. A repair & protection system was required to extend the life of the asset.

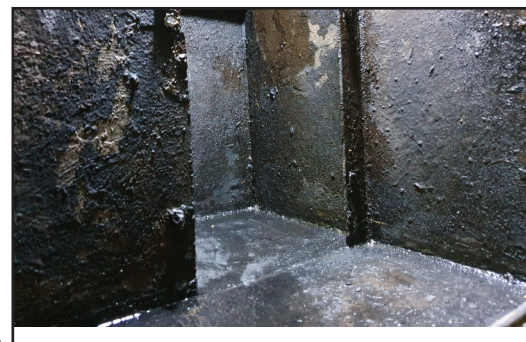
1. Existing coating system breaking down
2. Belzona Superwrap II system applied to the base of the tank
3. First coat of Belzona 5811 applied
4. Second coat of Belzona 5811 applied & left to cure

The application was carried out in a modified version of Belzona System Leaflet VPF-11 The tank internals were grit blasted to SA2.5 & 75 microns. All of the existing lining was removed. Areas of pitting and metal loss were faired with Belzona 1212. The full tank floor was then reinforced with the Belzona Superwrap II system. Two coats of Belzona 5811 were then applied over all areas of the tank internal to provide future corrosion protection.
