BELZONA PROTECTS TANK FROM EXTERNAL CORROSION

APPLICATION SITUATION
A tank required protection from external corrosion at a food production facility.

PROBLEM
External corrosion and chemical attack of the existing coating

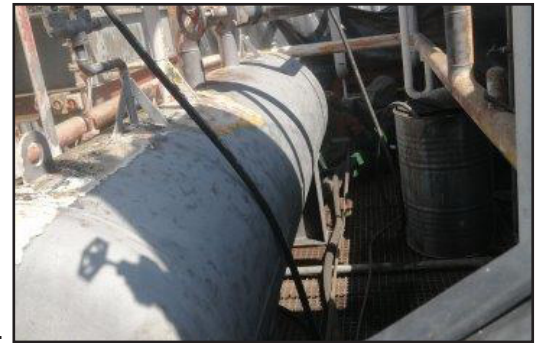
1. Tank prior to surface preparation
2. Tank during surface preparation
3. Tank post surface preparation
4. Completed Application
