BELZONA REPAIRS MULTI-STAGE PUMP

CUSTOMER
South Africa

APPLICATION DATE
2021

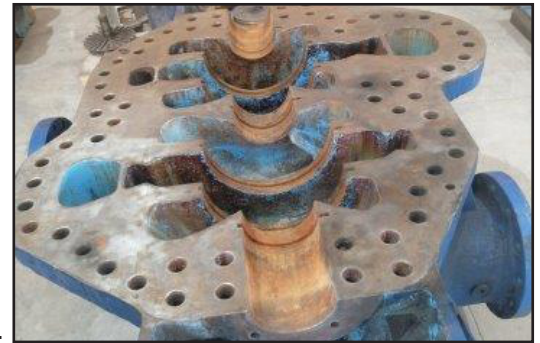
The process fluid had, over time, worn away the existing lining and damaged the substrate.

1. Before Repair
2. After Blasting
3. Rebuilt
4. Finished application
