## BELZONA RESTORES AND PROTECTS A HYDRO UNIT

60 year old Kaplan hydro power unit.

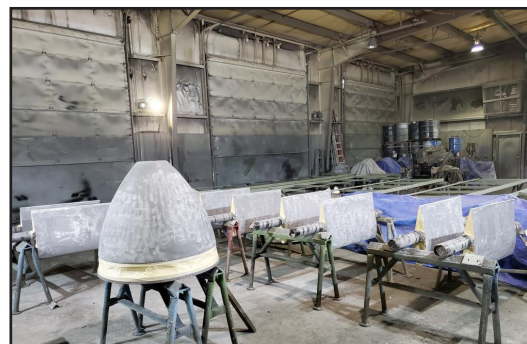
1. Belzona 1111 applied.
2. Belzona 1341 applied.
3. Assembled, and final touch-ups complete.
4. Unit reinstalled.

The parts were all grit blasted and washed with solvent. Belzona 1111 was used to smooth over the wear and cavitation in a full skim coat. Once cured, the Belzona 1111 was sanded down to the required profile, and frost blasted. Two full coats of Belzona 1341 were then applied. As per Belzona system leaflet VPF-01, VPF-02.
