## BELZONA SAVES CAST ALUMINIUM MANDREL

**CUSTOMER**  
Leicester

**APPLICATION DATE**  
Dec-21

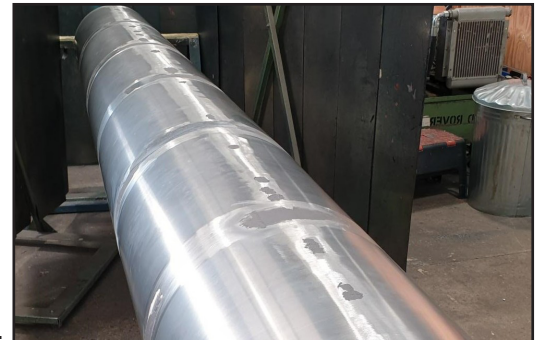
1. Belzona 1511 applied
2. Belzona 1511 applied (close-up)
3. Mandrel repair complete with Belzona 1511 smoothed
4. Close up of completed works

The product was applied in accordance with Belzona System Leaflet MPT-1. After surface preparation, the Belzona 1511 was applied to the surface and smoothed down until it sat flush with the aluminium substrate.
