BELZONA REBUILDS & PROTECTS BEET WASHERS

Sugar beet washers used to clean sugar beets in order to calculate average cost of clean sugar beet vs. dirty sugar beet were worn and damaged.

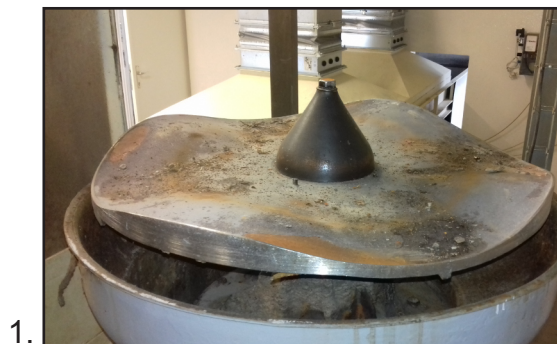
Due to the demanding nature of the sugar beet washers operation - humidity, abrasion and erosion - leading to accelerated rates of corrosion and wear resulting in through wall defects due to repeated abrasion and erosion from the sugar beet during operation.

1. Deteriorated Beet Washers in Situ,
2. Partial Belzona 1812 coated Wash Bowl,
3. Partial Belzona 1812 coated Lid,
4. Top Coated Lid using Belzona 1321

The wash bowl and top lid, were grit blasted prior to being rebuilt to their original profile using Belzona 1111. This was followed by the application of Belzona 1812 which has ceramic fillers inside to reduce and combat the abrasive wear, providing resistance to fine particle abrasion in particular. The bowl and lid were then coated using Belzona 1321 to provide a smoother surface on top of the sacrificial lining. The application was carried out in accordance with Belzona System Leaflet GSS-5 & GSS-9.
