BELZONA REPAIRS AND PROTECTS DRAFT TUBE

Hydroelectric Power Plant, Turkey

Rebuild and repair of a draft tube used as part of a Hydroelectric process.

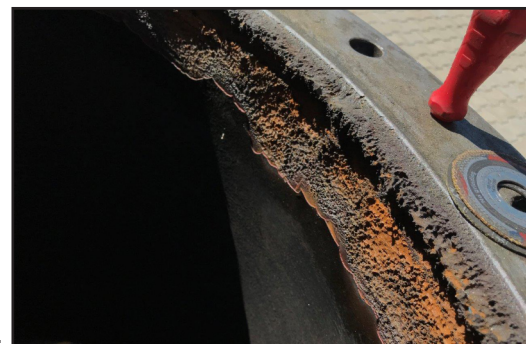
Corrosion and cavitation on the draft tube caused by pressure fluctuations.

1. Surface loss caused by corrosion and cavitation
2. After mechanical cleaning
3. Preparation for the application of the second layer of Belzona 1321
4. Coated with Belzona 1321 in two layers

This application was carried out in accordance with a modified version of system leaflet VPF-01. After the surface preparation, Belzona 1311 was used to resurface the profile. Once the damaged areas had been repaired, the 40 cm inner part of the draft tube where cavitation was intense, was coated with Belzona 1321 in order to provide cavitation and erosion resistance.
