BELZONA PUMP COATING OFFERS A SAVING OF UP TO 20% ON ENERGY COSTS

UK Automotive Manufacturer

Feb-22

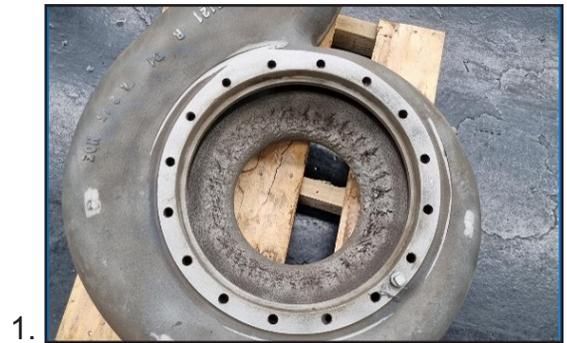
The pump casing had corrosion and erosion damage around the surface area where the open impeller vane tip runs. One of the pumps had its performance analysed on a test rig. The hydraulic efficiency was found to be down at 38.3%.

1. Pump casing with corrosion and erosion damage
2. Erosion repaired using Belzona 1111

The heavily eroded volute casing was rebuilt with Belzona 1111. It was then re-profiled to suit the impeller vane tips before Belzona 1341 was applied to improve the units' hydraulic efficiency, flow rate and head characteristics. The application was completed in accordance with Belzona System Leaflets CEP-01 and CEP-03.
