INTERNAL JOINT REPAIR TO STAINLESS STEEL PASTEURISER AT A BREWERY

The internal seal between two sections of the stainless steel pasteurising bottling line had developed a leak.

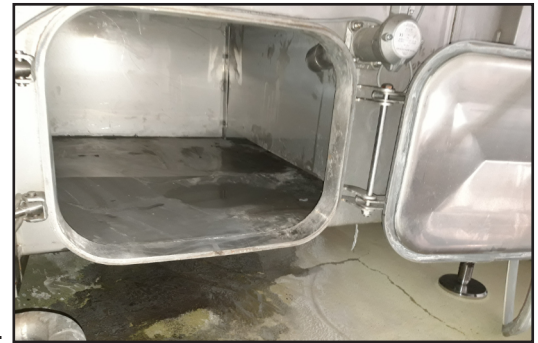
A stainless steel pasteurising bottling line had a large leak from a joint. The pasteurizer could not be disassembled to replace the gasket and therefore the only option was to seal the joint in situ.

1. Leaking pasteuriser
2. Surface of the seam prepared prior to repair
3. Belzona 1511 used to bond plates in place
4. Completed repair
