BELZONA REPAIRS CHEMICAL STORAGE ROOM FLOOR

Doncaster, UK

Mar-22

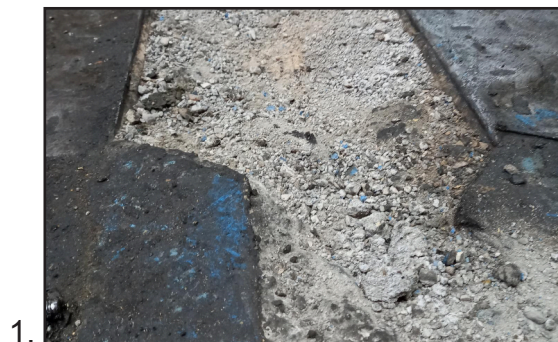
Steel tiles had failed in one area of a chemical storage area, leaving damaged concrete. Any repairs needed to be able to protect against water and general chemical use.

1. Target area identified for training purposes
2. Cleaning out the loose and friable materials
3. Belzona 4911 Conditioner mixed and applied
4. Belzona 4131 laid, compressed and smoothed to finish

All loose and friable materials were removed from the target area, using a wire brush, soft brush and compressed air. The area was conditioned using Belzona 4911 (TX-Conditioner). Following the conditioning, Belzona 4131 was applied, and were finished level with the rest of the floor.
