BELZONA REPAIRS FRANCIS TURBINE IN HYDRO-POWER PLANT

APPLICATION SITUATION
Coating of 1 out of 3 Francis Turbines used to power a Hydro-electric plant located within a dam in Portugal.

PROBLEM
After years in service the Francis turbine has began to corrode and erode.

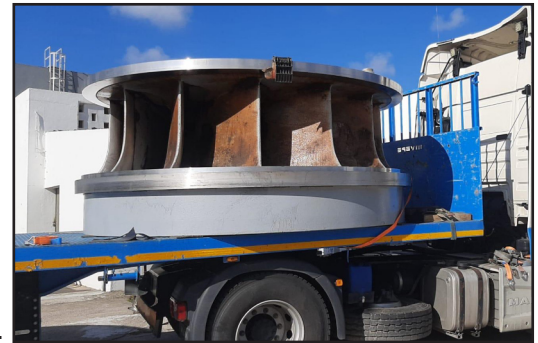
1. Francis turbine prior to application, visibly damaged
2. Francis turbine after grit blasting
3. First coat of Belzona 1341 applied
4. Final application
