BELZONA PROTECTS SWITCH GEAR BOXES AT A WIND FARM

Wind Farm, TX

Switch boxes at the base of turbine columns.

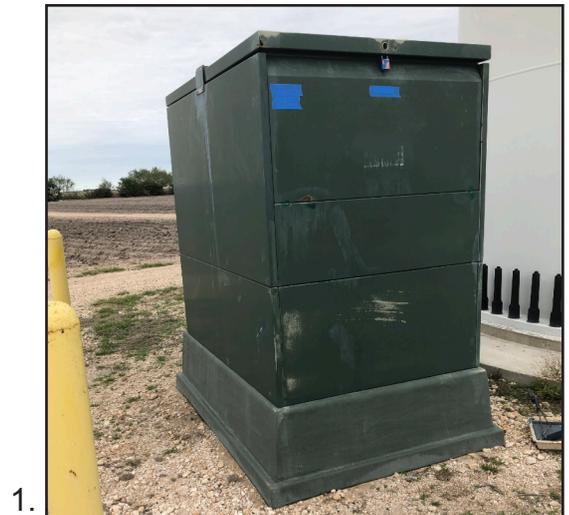
Damage on the metallic surface caused by corrosion from the salt environment. If neglected, wall thickness deteriorates and the asset integrity becomes compromised.

1. The surface is cleaned and manually prepared.
2. Belzona 3921 Conditioner is applied.
3. Belzona 5111 is applied and the applications is complete.

The location of the switch gear boxes made it easy to prep and apply coatings. Abrasive blasting was not allowed. Orbital sanders were used to acquire a surface required to apply coatings. First, the Switch Gear Boxes were coated with Belzona 3921 Conditioner that is zinc rich and also acts as a corrosion inhibitor. Then, Belzona 5111 was then applied for the finish UV protection and final environmental protection. The application was carried out in accordance with the Belzona System Leaflet CEP-4 and Instructions for Use.
