BELZONA® REPAIRS WORN OUT FAN SHAFT DUE TO ABRASION AND BEARING SEIZURE

APPLICATION SITUATION
Fan shaft

PROBLEM
Deeply worn out due to abrasion in Fan shaft due to abrasion and bearing seizure.

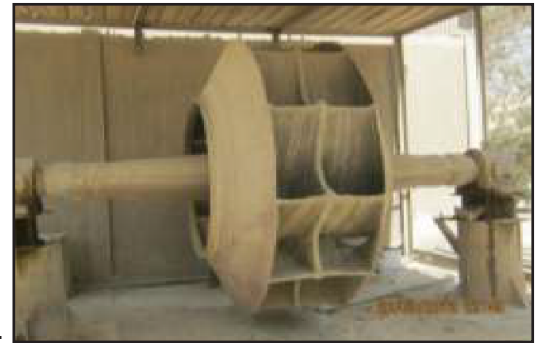
1. General view of the Fan shaft.
2. Wear area in Fan shaft.
3. Fabricated former to get the required dimensions.
4. Application Done.
