TURBO SEPARATOR REPAIR WITH BELZONA 1818

Turbo separator in Paper recycling plant

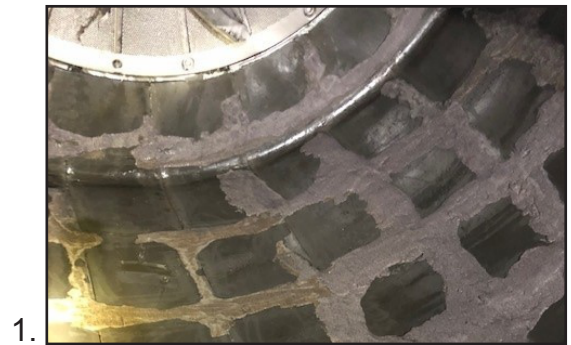
The Turbo Separator is a disc screen specially designed for course screening, primarily removing light and heavy impurities from wastepaper. The unit is lined with thick Basalt tiles and has a hard-wearing grouting compound applied over the joints between the tiles. Over the years, this grouting compound would wear away leaving the joints unprotected. This is a very abrasive environment.

1. Worn grouting system
2. Application in progress
3. Application in progress
4. Application complete

After cleaning out the pulp, the Turbo separator was dried out using rags. Surface preparation was achieved using a diamond blade on an angle grinder to create a "key" for Belzona 1818. Belzona 1818 was mixed and applied with ease, including overhead areas.
