BELZONA 1818 SCREENED FOR SUCCESS

A major paper recycling plant that operates almost full time and only stops production for twelve hours, once a month to perform routine maintenance. To avoid erosion and abrasion along in an attempt to prolong the life of their Turbo Separators, they are lined with two-inch-thick ceramic tiles. This type of disc screen is designed specifically for coarse screening in pulp strainers with high trash and flake material, such as recycled paper, which is what the mill uses as a feedstock to make 100% recycled kraft paper and packaging.

Belzona 1818

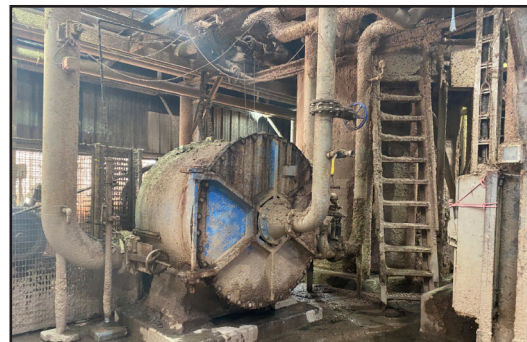
1. External view of Turbo Separator in the mill
2. Internal view of Turbo Separator showing damaged/lost tiles
3. Application of 1818 commencing
4. Additional 1818 being applied

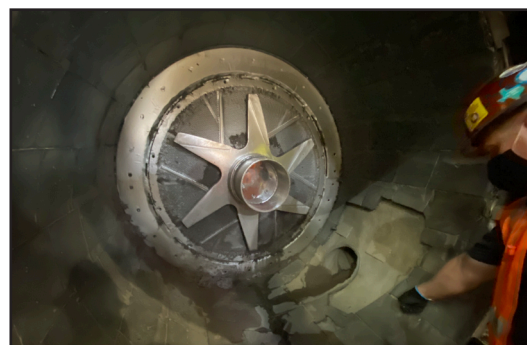
2.

During normal operation, a large metal foreign object went through the turbo separator. The internal lining was severely damaged in a 4ft x 3ft area. The process of replacing tiles is a time-consuming operation and the mill did not have the time available to make their typical repairs. In order to operate the equipment, they needed a repair to be completed in less than twelve hours from shut down to start up.

The application was completed using a modified version of SHM-07. Loose and damaged tiles were removed. The steel substrate and ceramic tiles were abrasive blasted to create a suitable profile. Belzona 1818 was used to rebuild the area of lost tiles and provide an abrasion-resistant coating.
