## DAMAGED LOADING BAY STAYS STRONG WITH BELZONA

Industrial gas supplier, UK

Concrete loading area for gas cylinders.

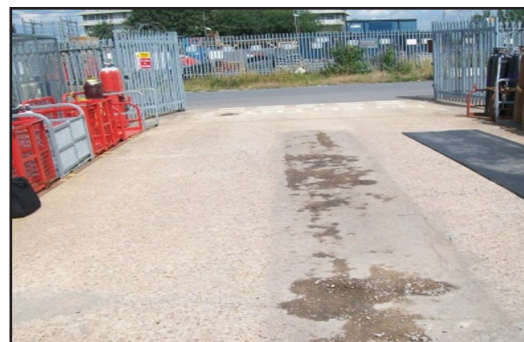
The surface of the concrete ramp had become damaged due to impact from the gas cylinders when being loaded and unloaded, even though they are dropped onto a rubber mat. The uneven surface was making it increasingly difficult for the tall narrow cylinders to stand up safely.

1. 8.5m x 5m concrete loading area damaged by impact
2. Extent of the damage
3. Repaired with 6mm of Belzona 4131
4. Application revisited in 2021 after 9 years in service

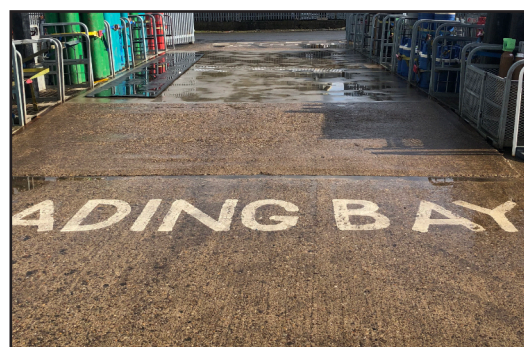
4.

This is a common problem on many gas distribution sites across the UK. Belzona was selected firstly for its ability to protect against impact and abrasion. Secondly for being impermeable and resistant to frost damage. After nine years of constant loading and unloading of gas cylinders the loading bay has been revisited in May 2021 and was found to be in excellent condition. The client is very impressed with the Belzona solution provided and has since implemented a variety other successful Belzona applications across their UK sites.
