BELZONA ABRASION PROTECTION OF VACUUM MACHINE PARTS

Cement Plant, Macedonia

Housing, pipes and cone fittings from truck vacuum machine

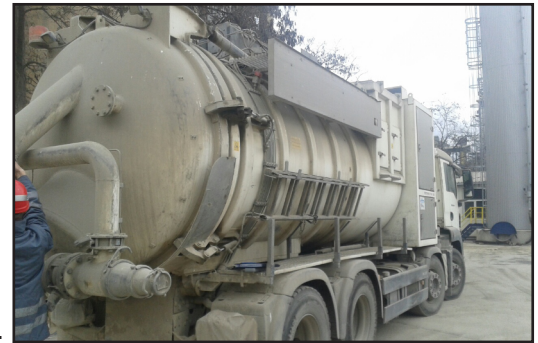
1. Appearance of the vacuum material collection machine
2. Preparation of the inner surfaces of the housing
3. Belzona 1812 applied on the internal surface
4. Belzona 1818 applied on the internal surface.

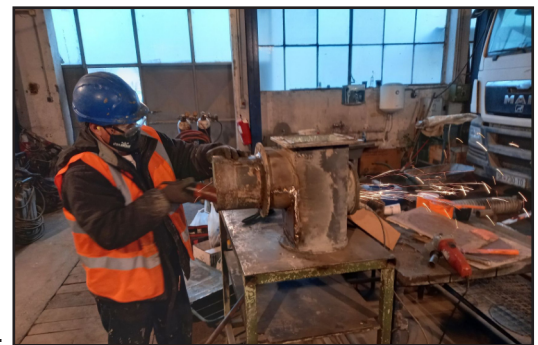
High wear of the housing, pipes and cone fittings, caused by aggressive abrasion of various materials in the production process
