## BELZONA REPAIR AND PROTECT OFFSHORE CLOSED DRAIN TANK

Internal repair and coating of offshore FPSO closed drain tank.

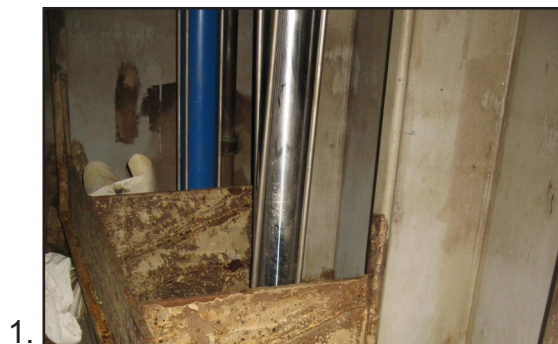
Severe pitting corrosion in bottom section of internal closed drain tank, due to coating failure. Metal loss in areas measured to 6-8mm deep.

1. Corroded tank bottom
2. Severe pitting corrosion
3. Grit-blasted surfaces and rebuilding of pits using Belzona 1111 Supermetal
4. Tank bottom coated with Belzona 5811 Immersion grade.
