BELZONA REPAIRS AND PROTECTS 2 STAGE SEAWATER PUMP

CUSTOMER
SHIPYARD, TURKEY

APPLICATION SITUATION
2-stage seawater pump case

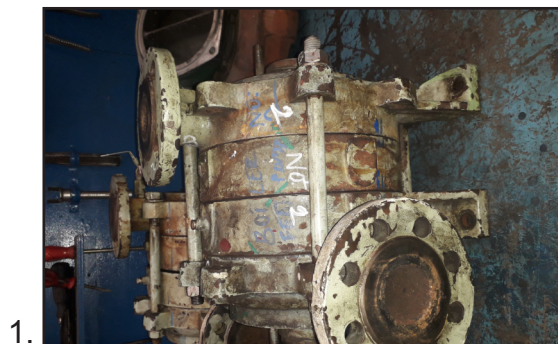
PROBLEM
Pump case surface was severely damaged due to cavitation from seawater and corrosion.

1. 2-stage seawater pump with high cavitation
2. After Grit-Blasting
3. Application of Belzona 1311
4. Application of Belzona 1321
