BIG VACUUM OVEN REPAIR WITH BELZONA 1593

CUSTOMER
Slovakia

APPLICATION DATE
2019

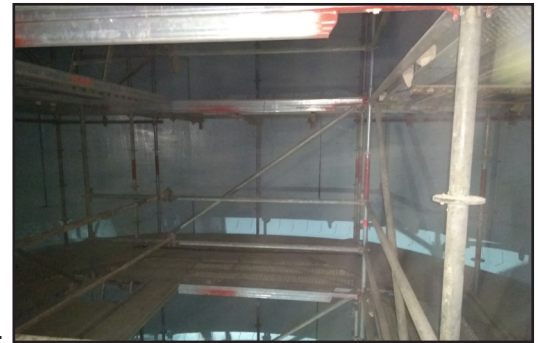
- PICTURES**
1. It was necessary to erect up scaffolding.
 2. Steel prickles were coated too.
 3. 2nd coat of Belzona 1593 applied.
 4. Oven ready to use.

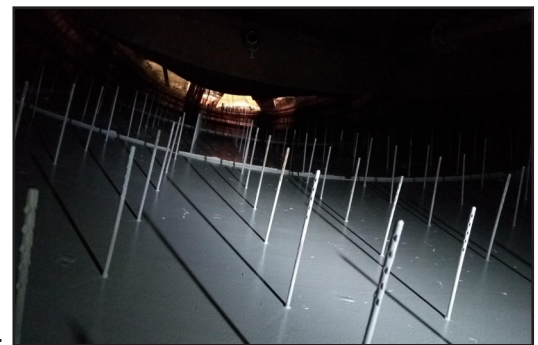
2.

PROBLEM
The problem was: steel prickles inside which keep the oven insulation are degraded from acids throughout the life. Oven needed the protection against acids in high temperature.

APPLICATION METHOD
The application was performed in accordance with Belzona system leaflet TCC-5. After blasting and cleaning, the oven was applied with Belzona 1593 in 2 layers. The first coat of Belzona 1593 was applied at 375 microns. After 12 hours the second coat was applied at 375 microns. Complete coating was finished in 2 days.
