BELZONA HELPS PROTECT OFFSHORE PLATFORM LEGS AT WATERLINE

APPLICATION SITUATION
Original corrosion protection damaged on platform legs.

PROBLEM
Corrosion of platform legs in the splash zones.

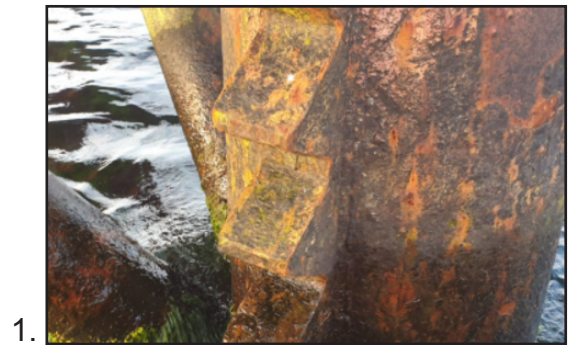
1. Corroded platform legs
2. Surface preparation
3. Belzona 5831 in use.
4. Platform
