## BELZONA COLD PLATE BONDING REPAIRS & REINFORCES SILOS

Mining: Corrosion repairs needed to 8 x Nickel Storage Silos.

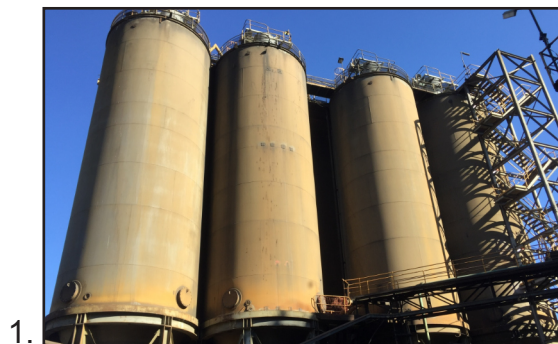
1. The 8 x Nickel Storage Silos
2. Pitted and corroded Silo wall.
3. Plates in place going around the Silo.
4. Completed application.

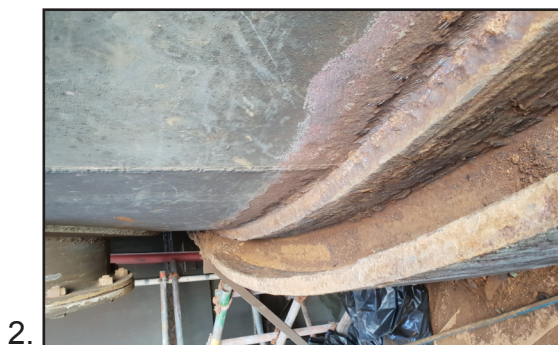
Inspections were carried out on the Silos and they were found to have severe corrosion loss to bottom sections of all Silos. To empty each Silo would have been a major cost and because the Silos are internally coated welding was not an option.

The application was carried out by Cold Bonding 200mm x 1m rolled plates with Belzona in accordance with the Method Statement for Cold Plate Bonding. After abrasive blasting, all corrosion holes were first repaired by filling with Belzona 1111. Belzona 1111 was then applied to the plates which were bonded into place. Belzona 1121 was used when temperatures rose above 35 C to allow more working time.
