BELZONA® SEALS INSIDE TANK THE STEEL SHELL TO THE CONCRETE FLOOR

A steel tank with a concrete floor with D=13 m, h=12 m, V=1500 m³ used to store a mix of salt water and oil.

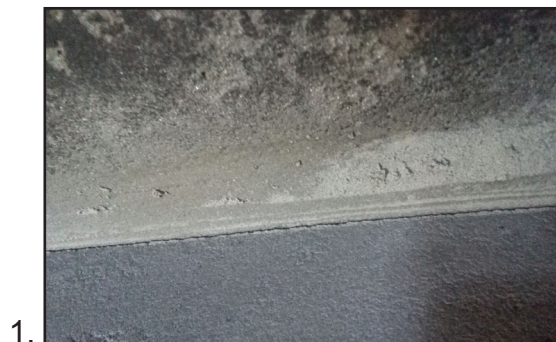
Between the concrete floor and the steel shell there was a gap of up to 6 mm that had to be sealed to stop the tank from leaking.

1. Initial view of the gap between the tank shell and the concrete bottom.
2. Surface preparation in progress.
3. NBR rubber cord forced into the gap
4. The finished application with Belzona 4111 applied on the left picture and the Belzona 1321 coating on the right picture.

In order to carry out the repair, the existing gap had to be enlarged, the contaminated concrete was removed, and the steel wall was cleaned and sandblasted, followed by degreasing the surface. In the existing gap a NBR rubber cord was inserted by force, and Belzona 4111 Magma Quartz was used to close the gap to the shell and restore the concrete thickness. The surface restored with Belzona 4111 Magma Quartz and the surrounding area on the steel shell where coated with a two coat system of Belzona 1321 Ceramic S-Metal, in order to provide corrosion protection.
