CHEMICAL CANALIZATION ENTRY REPAIRED WITH BELZONA

Petrochemical company, Slovakia

2016

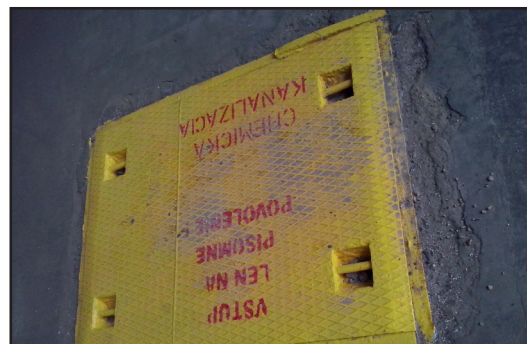
The concrete was destroyed from chemicals.

Corrosion of the steel frame and damage to the concrete

1. Chemical canalization entry.
2. Belzona Conditioner application
3. Belzona 4131 application
4. Belzona 5811 in 2 layers
