BELZONA PROTECTS NEW BUTYL GLYCOL ESTERS TANKS

Lubin, Poland

Butyl glycol esters tanks needed a protective coating.

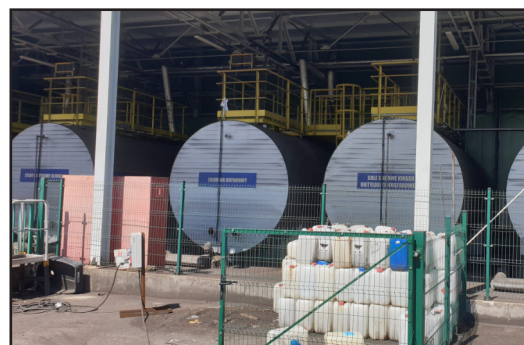
1. Asset Location
2. Butyl glycol esters tanks
3. Previous coating corrosion protection damage.
4. Inspection after one year

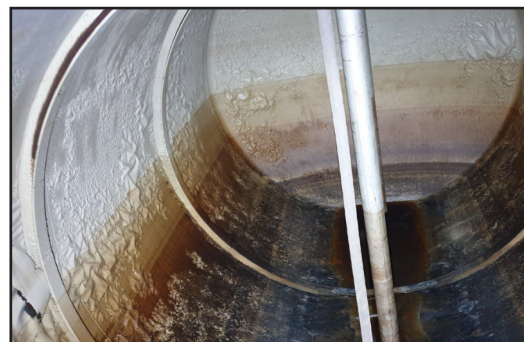
3.

Internal corrosion of tanks damaged due to corrosion and failure of previous coating.

The client had used a cheap coating in containment area first and after it failed decided to spend a little more money to make it last a long time. Belzona 4311 was applied into the internal lining of the tank and is still in good condition.
