REPAIRING AND COATING OF THE CONCRETE SULPHUR TANK

CUSTOMER
Slovakia

APPLICATION DATE
2020

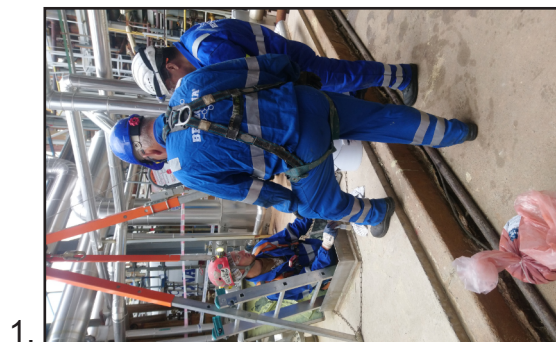
The concrete underground tank for liquid Sulphur was damaged. The longer wall of the tank crashed down. 100 % liquid Sulphur in this process can have a temperature up to 150°C and customer needed quick and quality repair.

1. Customer needed to repair concrete underground tank
2. After the Belzona 4981 application
3. Belzona 4181 application
4. Sulphur concrete tank ready to use

The application was carried out in accordance with Belzona System Leaflets TCC-9 and TCC-15. Damaged and loose concrete was removed. Then we used the blasting process. We made sure the surface of the concrete is clean/dry/free of any loose contaminants and then we used to condition the surface with your 4981. The eroded vertical surface of the tank was rebuilt with Belzona 4181. In the end Belzona 1392 has been applied.
