BELZONA KEEPS FISHING FOR 20 YEARS.

Perth, Western Australia

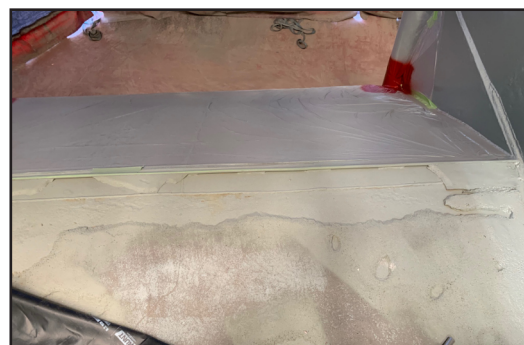
Now in 2020, some 20 years after the original application, some localized areas required attention and re-laying of Belzona 4111.

1. Fishing Trawlers
2. Stern ramp deck prior to repair
3. Close up of original 20 year old Belzona 4000 product
4. New repairs complete.

The localized areas were mechanically abraded and the Belzona 4111 was troweled into the areas to be patched.

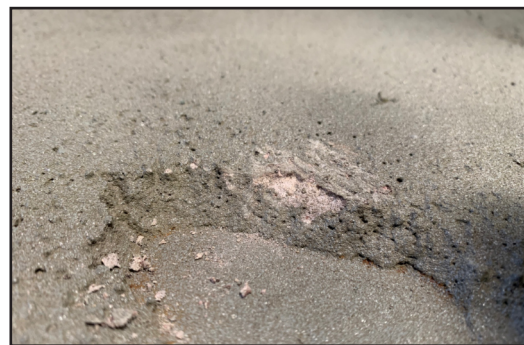
3.

The same engineer applied both Belzona products some 20 years apart - it was very evident that the original Belzona was extremely durable and robust making the decision to carry out the patch repairs with Belzona a very easy one.
